Assessment of Rock Slopes Stability Located on the Banks of the Khanas Dam Reservoir in the Nineveh Governorate, Northern Iraq.

A detailed study is conducted on the stability of the rock slopes at the two banks of the Khanas Dam reservoir located in the southeastern Sheikhan anticline, -Nineveh Governorate. The study includes seven stations distributed in both banks. The field survey is accomplished to determining the attitude of slopes and discontinuities of the rock blocks belonging to the Pilaspi Formation in the study area. The stability of the rock slopes is evaluated using Dips v: 6.008 program which uses kinematic analysis to predict potential structural failures (plane sliding, wedge sliding, flexure toppling and direct toppling), and SMARTool-v205 program used to determines the degree of the stability for each mode of failure. From the stability analysis results, it is found that there is possible occurrence of direct toppling at stations (SR1, SR2, SR3 and SL1), wedge sliding at stations (SR1, SR2, SR3, SL2 and SL3), flexural toppling at stations (SL1) and plane sliding at station (SR1). A program to evaluate the (slope mass rating shows the values of discrete (Slope Mas

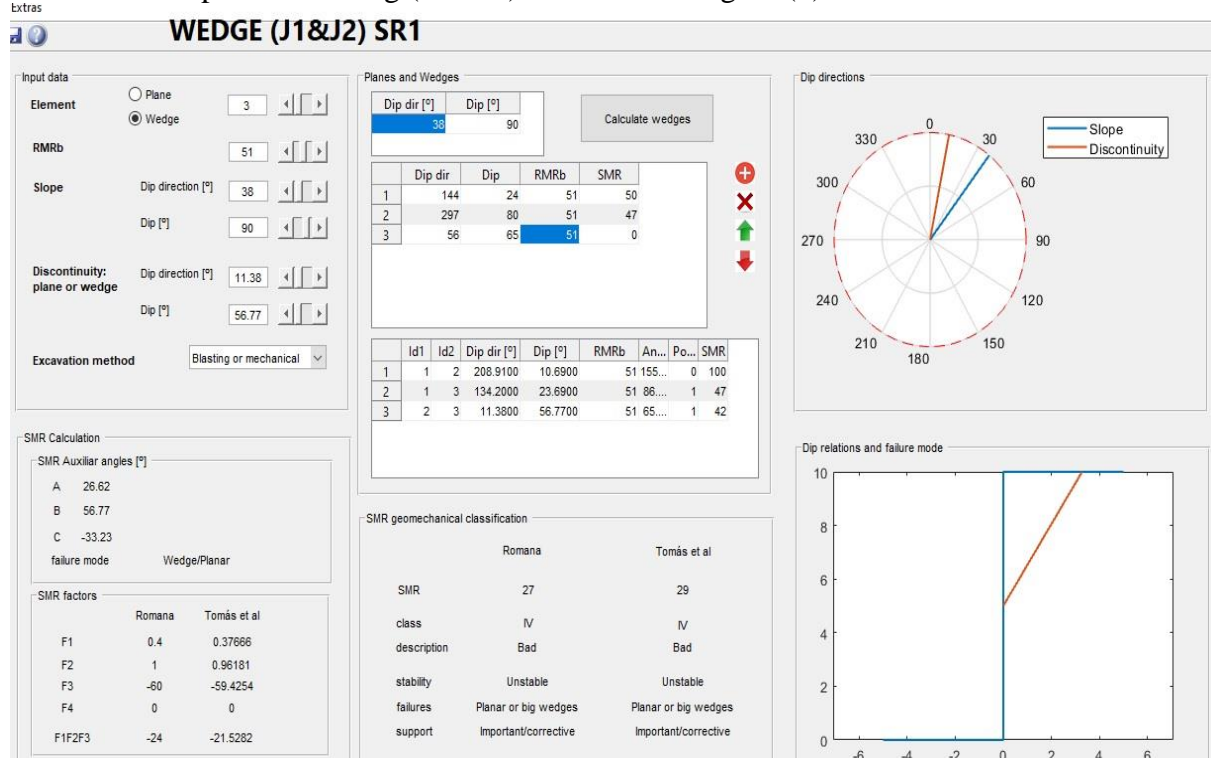
Fig. 3. Assessment of the rock slope stability at station (SR1) in the right bank, showing wedge sliding between (J1&J2) for both discrete-SMR and continuous (CSMR), using SMARTool-v205.

mass rating basic (RMR_b), and then we chose the paragraph in the program represented by method excavation and chose to it (blasting or mechanical), we will get on the parameter of (SMR), and get on the evaluations and the description of Slope Mass Rating discrete (SMR) classes according to Romana, (1985) and then status self-according (Tomas *et al.*, 2007) for continuous Slope Mass Rating (CSMR). as shown in Figure (3).

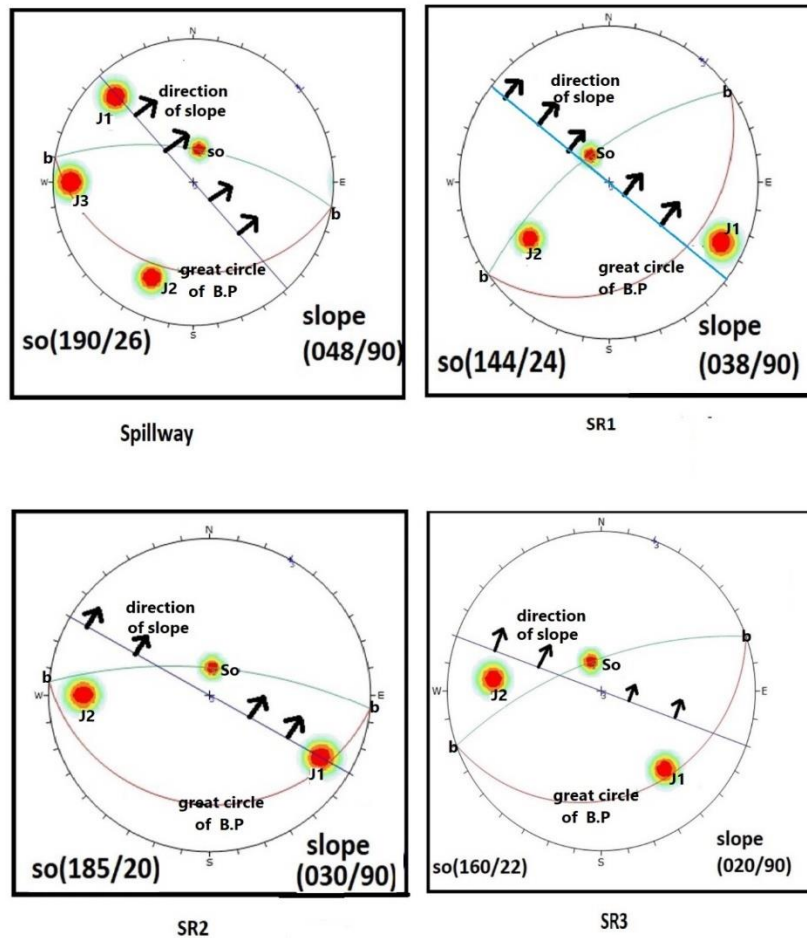
Fig. 5. Stereographic projection of stations located on the right bank. The photography direction at each station is (southwestern). So: represented dip direction of bedding plane. b: represented to strike of bedding plane, (J1, J2, and J3) represented for discontinuities, B.P: bedding plane.

During the stage, the joints on the rock blocks are projected after projecting the attitude of the bedding plane for the rock block represented by (dip direction/ dip amount), and then projecting the attitude of the slope. The three-dimensional stereographic engineering drawing of the station located on the right bank of the dam represented by the spillway station, first, second, and third stations are projected (Figure 5) (Plate 1). Then the same process took place by projecting the joints on the rock block of the left bank of the dam, by projecting the layer attitude of these blocks and projecting the slope attitude of the following stations the first, second, and third stations, as shown in the Figure (6) Plate (2).

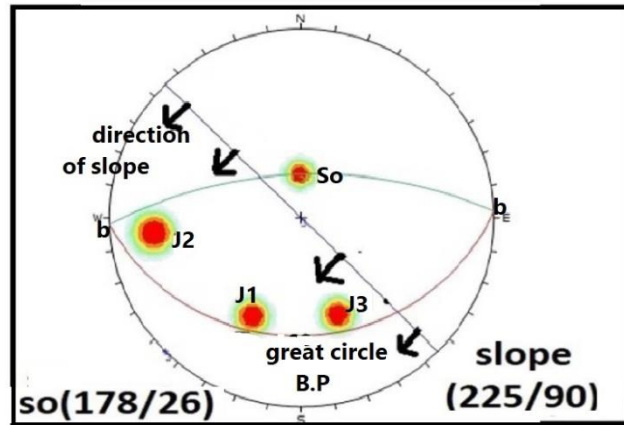
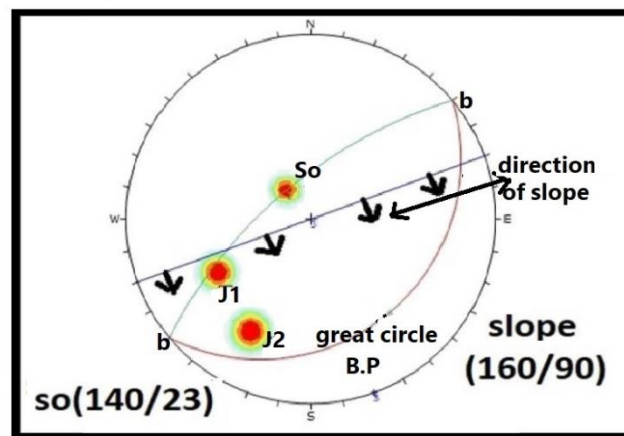
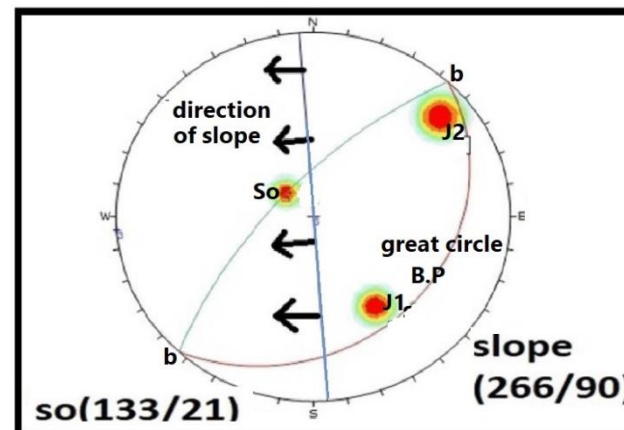
Fig. 6. Stereographic projection of stations located on the left bank. Photography direction SL1 (Northeastern), SL2 (Northwestern), SL3 (East-West). So: represented dip direction of bedding plane. b: represented to strike of bedding plane, (J1, J2, and J3) represented for discontinuities, B.P: bedding plane.

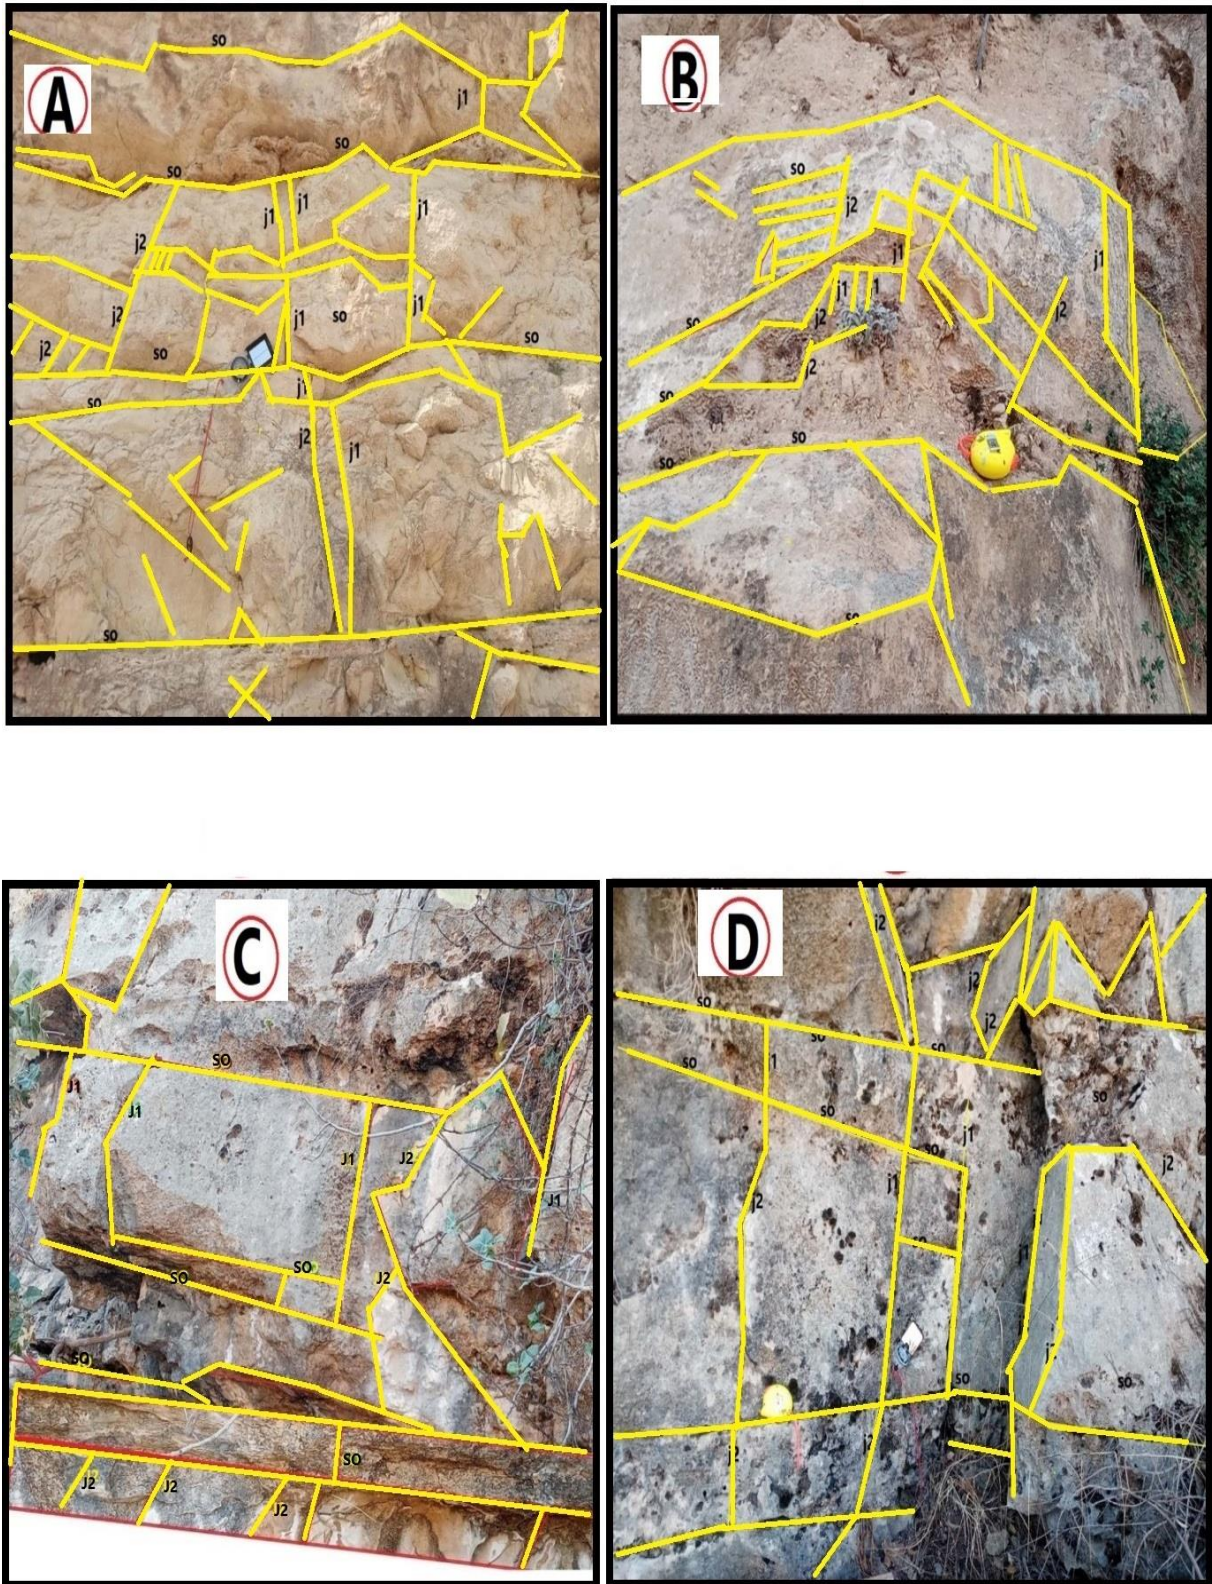
Plate 1: Pictures of the rock blocks located on the right bank of the dam, where (A) represents the spillway station, and (B) is the first station (SR1), and (C) is the second station (SR2), and (D) is the third station (SR3).

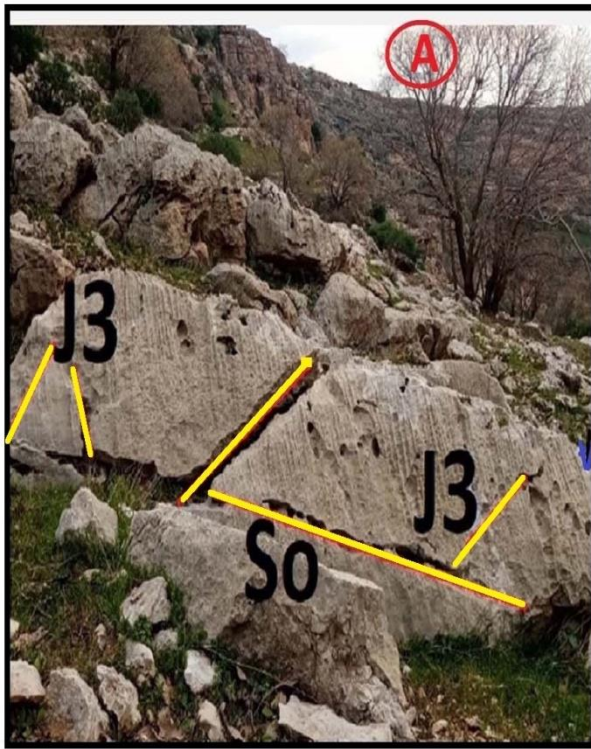
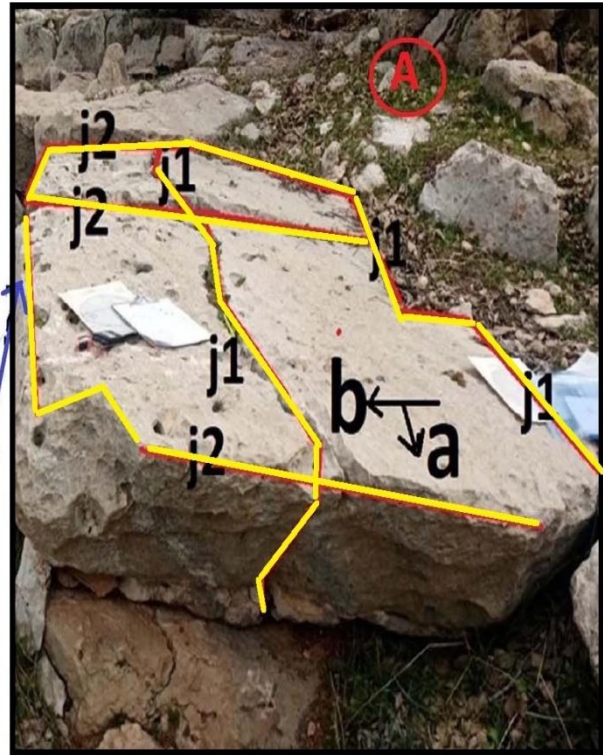
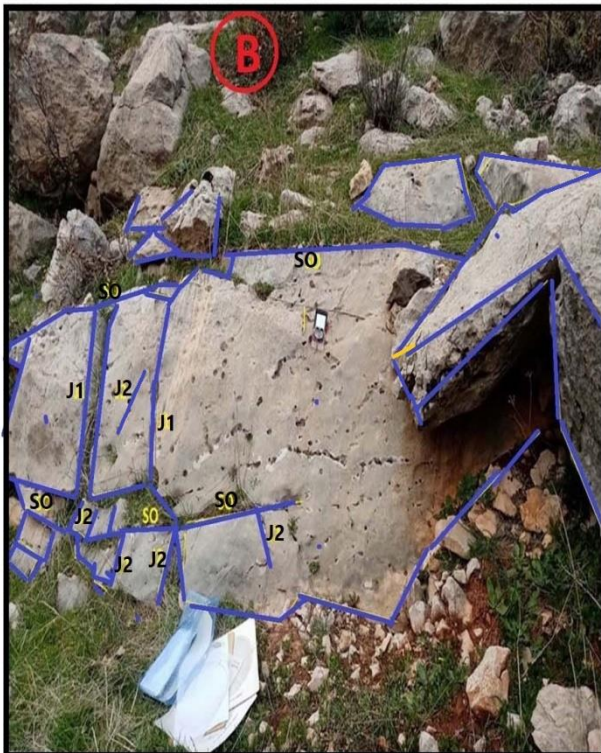
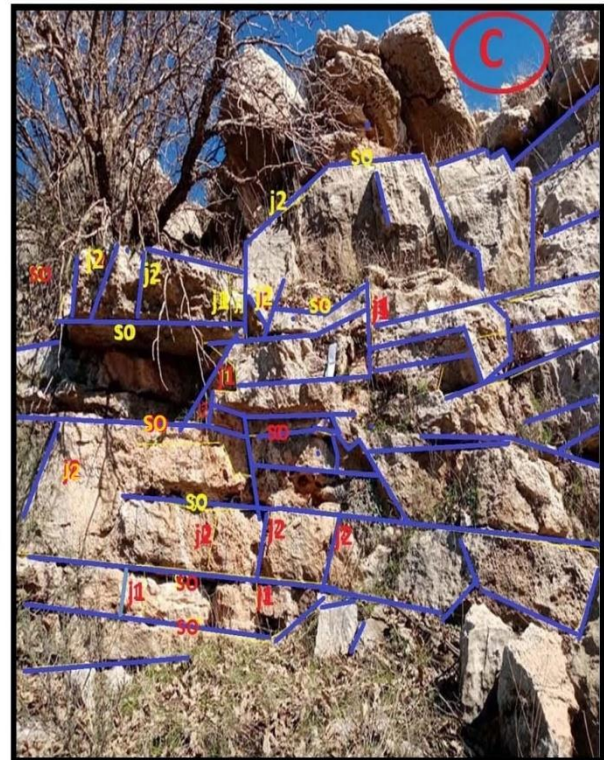
Plate 2: Pictures of the rock blocks located on the left bank of the dam, where (A) represents the first station (SL1) through two front and lateral view of the rock block, (B) the second station (SL2) and (C) the third station (SL3).

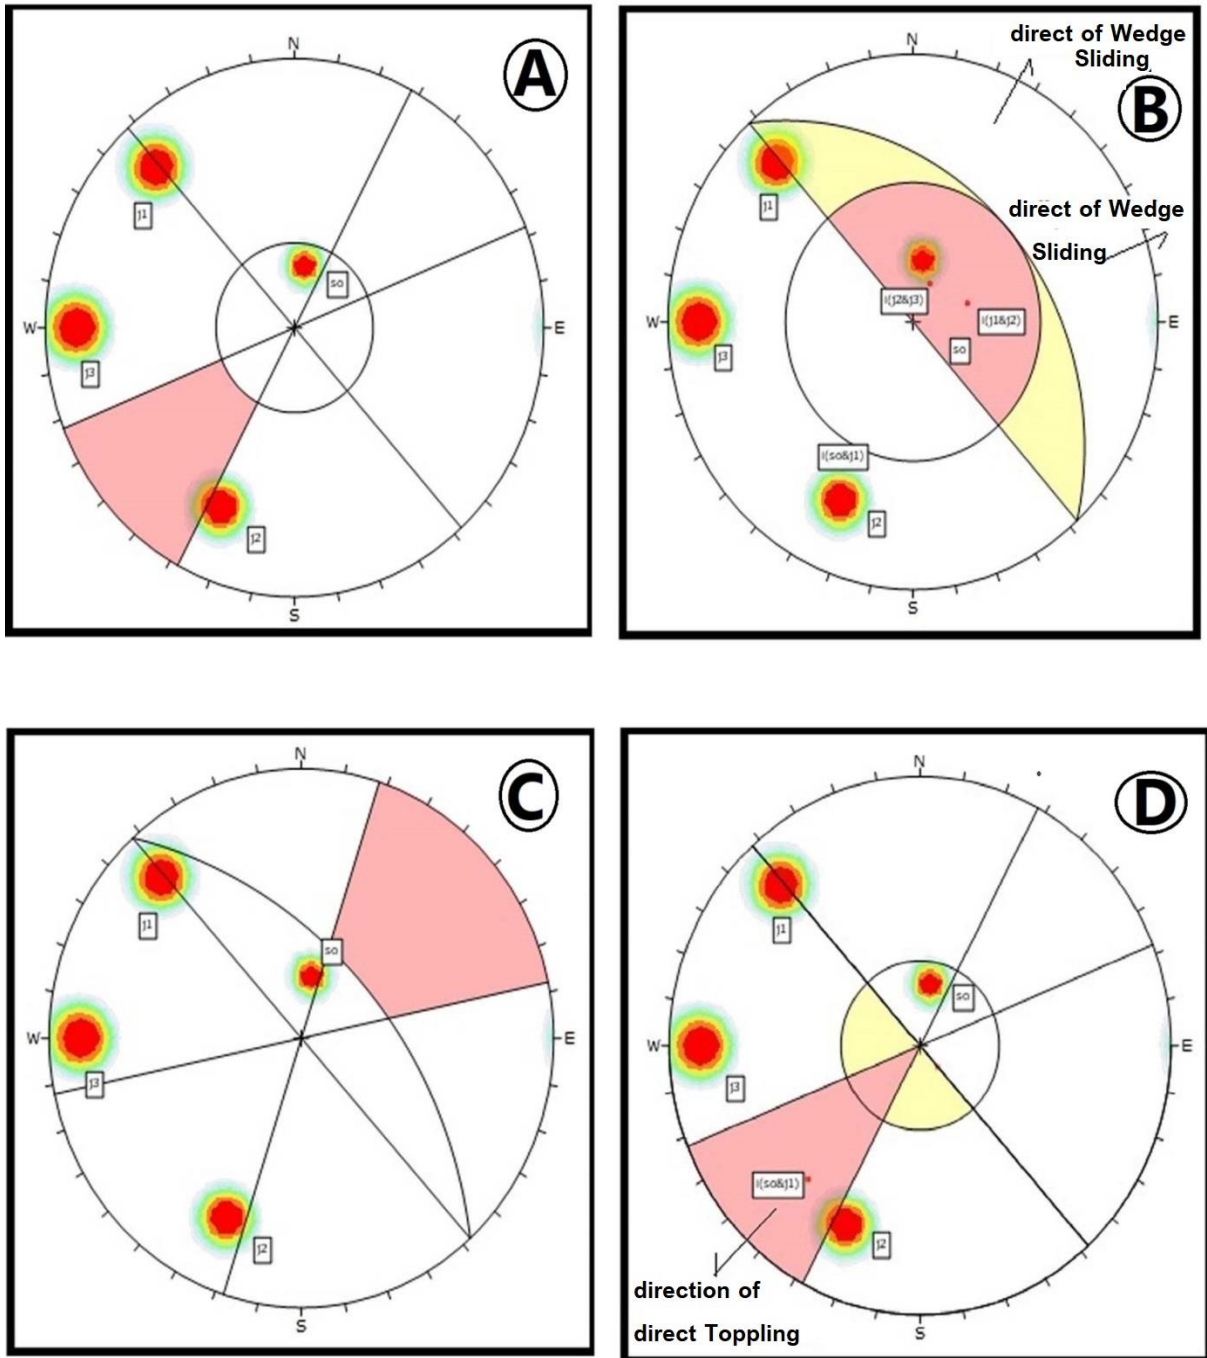
Fig. 7. Kinematic analysis of a spillway station with an attitude of slopes (048/90) A: There is no possibility of planar sliding. B: There is a possibility of wedge sliding. C: There is no possibility of flexure toppling. D: There is a possibility of direct toppling

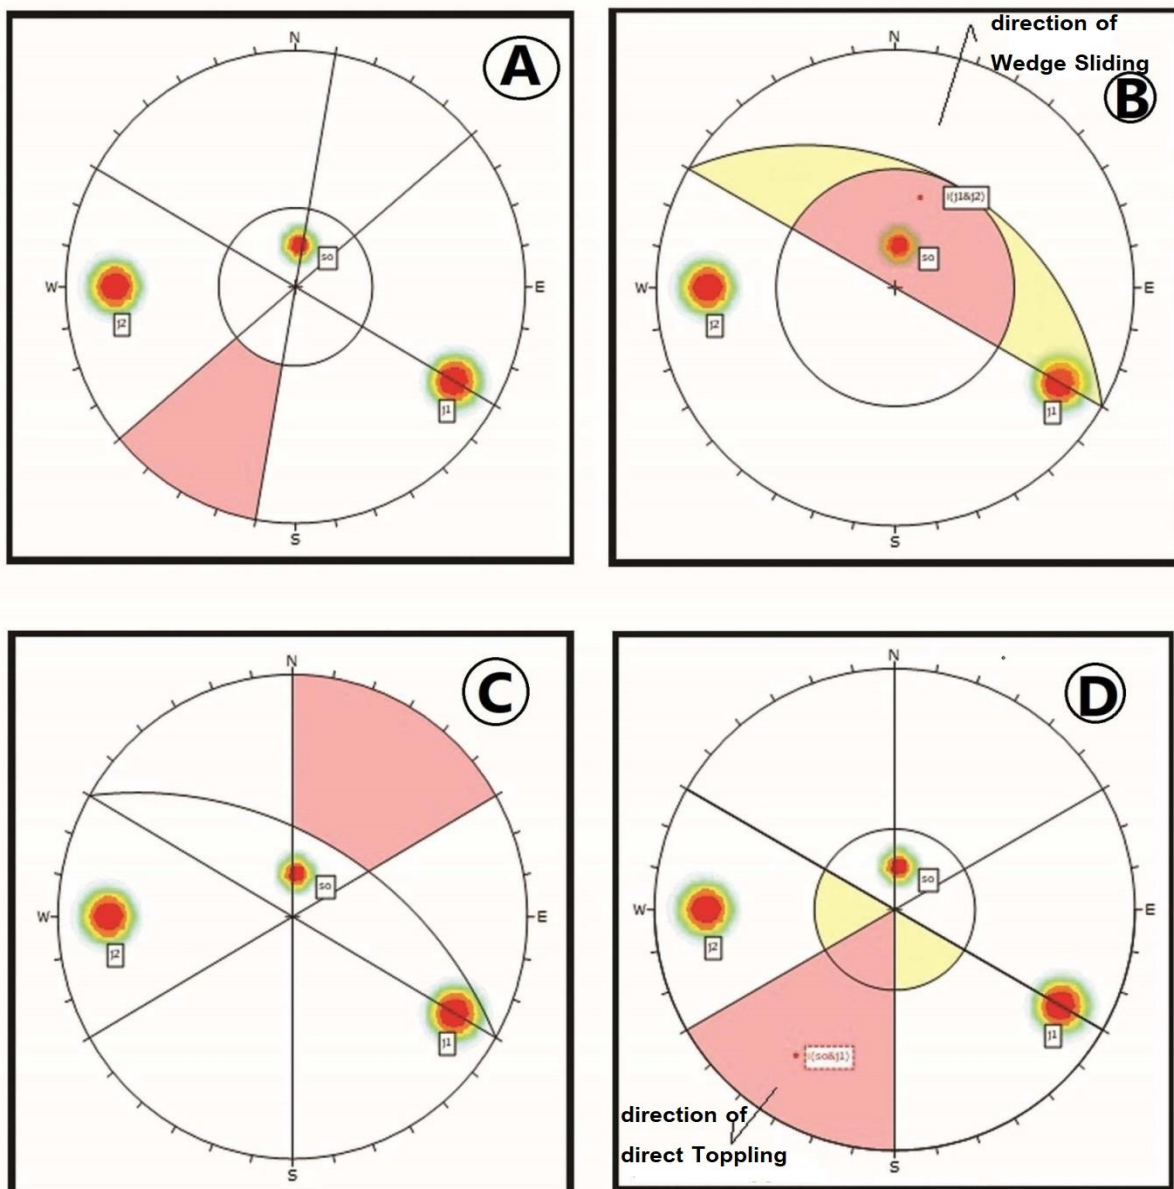
Fig. 9. Kinematic analysis of the second station (SR2) with an attitude of slopes (030/90) A: There is no possibility planar sliding. B: There is a possibility of wedge sliding. C: There is no possibility of flexure toppling. D: There is a possibility of direct toppling.

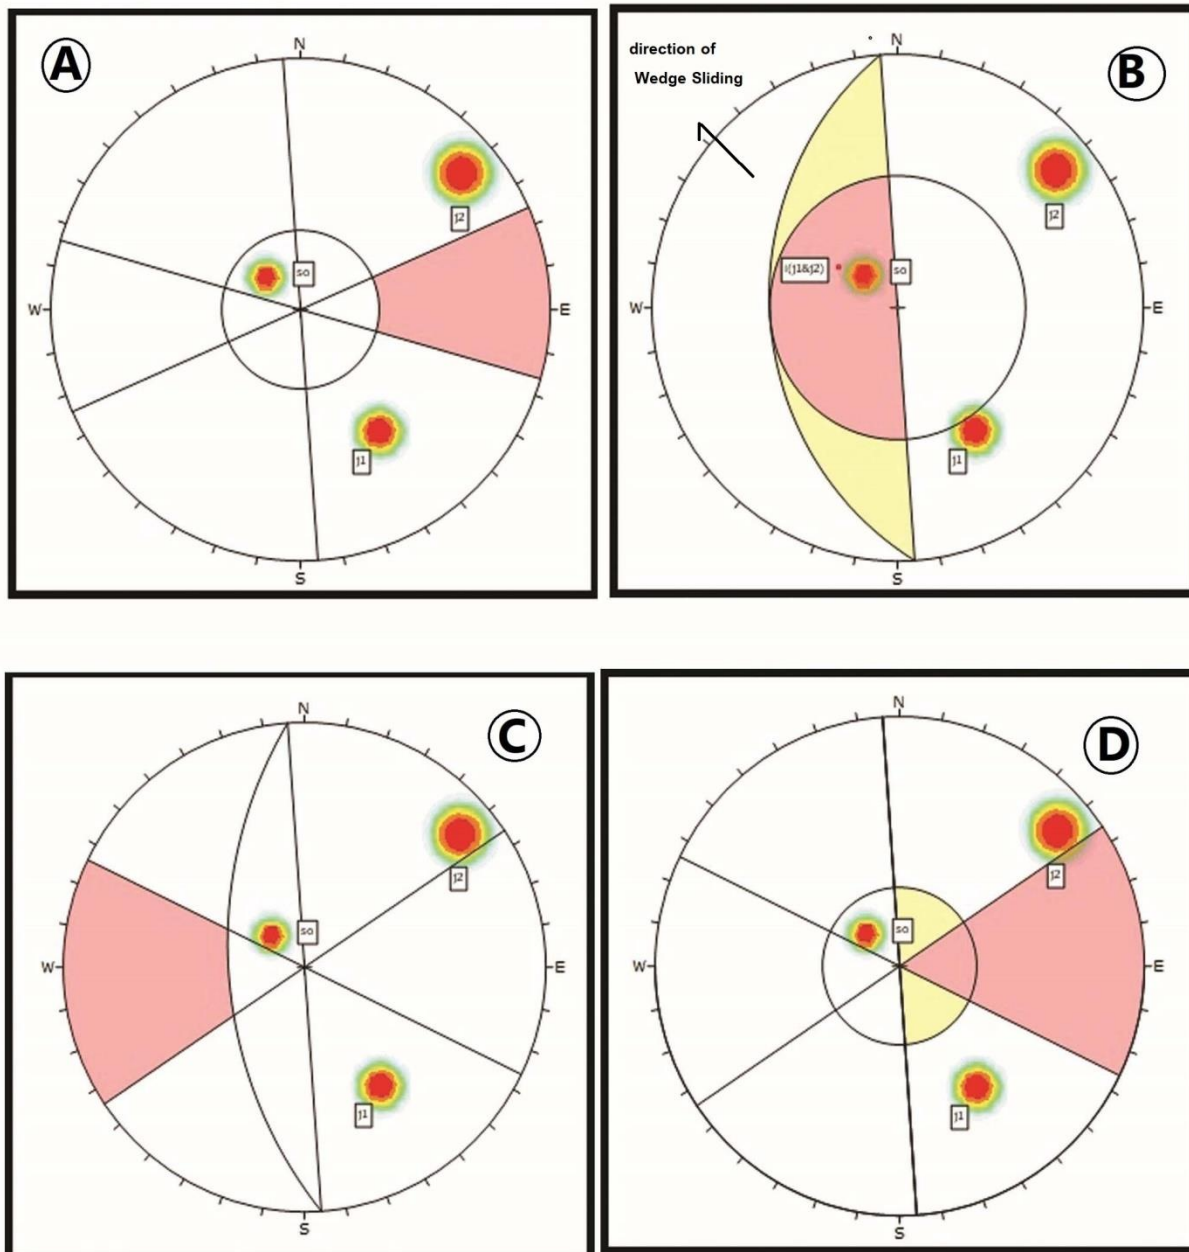
Fig. 13. Kinematic analysis of the third station (SL3) with an attitude of slopes (266/90) A: There is no possibility of planar sliding. B: There is a possibility of wedge sliding. C: There is a possibility of flexure toppling. D: There is no a possibility of direct toppling.
